Manhole Inspection Summary

Manhole # S29OO1025MH

Insp Date: **7/14/07 12:47 PM**

Location Address: **COLD SPRING LN**

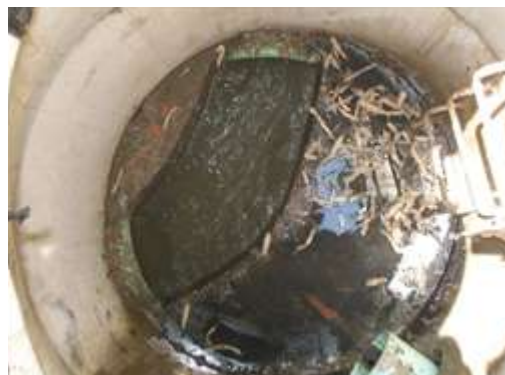
Top View

Adjsutment and Barrel infiltration. Bench debris.

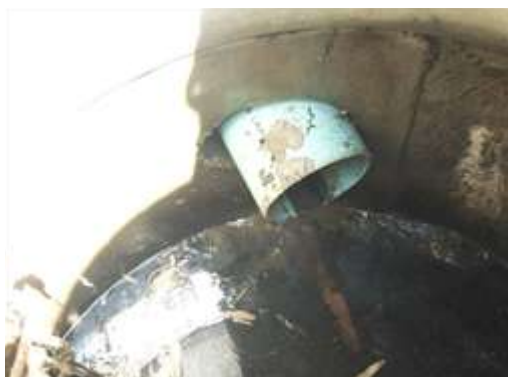
Defect

Barrel infiltration.

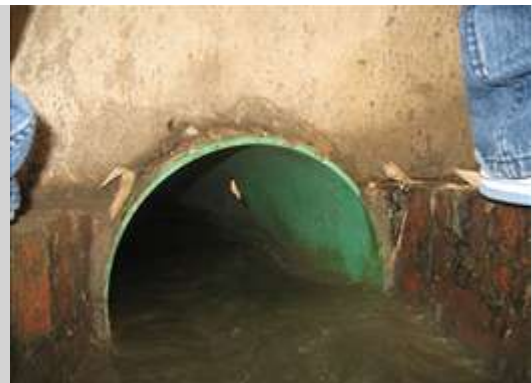
Pipe Out @ 12 O'Clock

15 in. Circular Gravity Sewer

Infiltration: **Evidence**

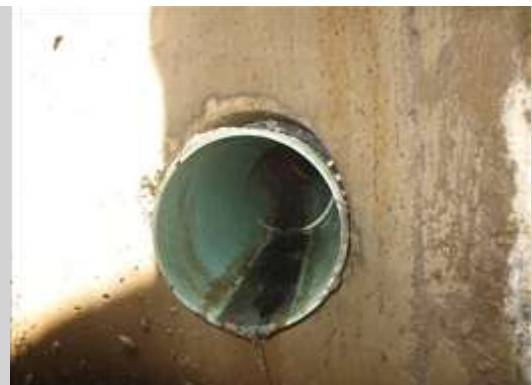
Pipe In @ 5 O'Clock

8 in. Circular Gravity Sewer

Infiltration: **Evidence**

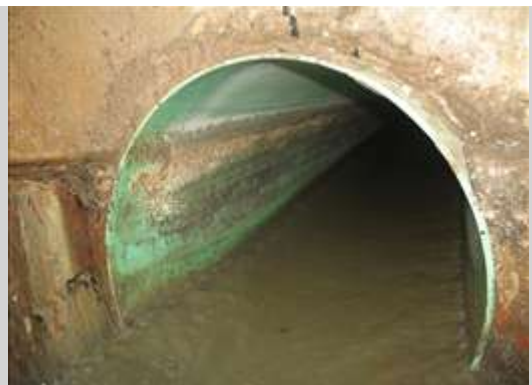
Pipe In @ 7 O'Clock

Comments **The I5 pipe seal is not flush the pipe.**

15 in. Circular Gravity Sewer

Deposits: ☐ None ☐ Mud ☐ Sludge ☐ Debris ☒ **Grease**

Deposits Extent: **Light**

Infiltration: **Evidence**
